Crevice Corrosion of Ni-Cr-Mo Alloys

P. Jakupi, D. Zagidulin, J.J. Noël, D.W. Shoesmith
The University of Western Ontario, Dept. of Chemistry
1151 Richmond, Suite 2, London, Ontario, Canada,
N6A 5B8 • Tel: (519) 661-2111 x86248

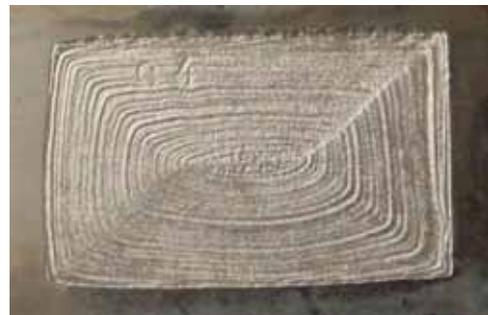
Figure 2: Image of a crevice corroded Alloy-4 specimen

In potentiostatic experiments creviced Alloy-22 and Alloy-4 specimens were polarized at +200mV and 0mV respectively for approximately 1 day. For both Alloy-4 and Alloy-22, the measured current was high (mA's) suggesting very little anodic limitation on crevice propagation. The measured current decayed in an oscillating pattern eventually to zero (figure 1). An optical micrograph of Alloy-4 (figure 2) showed that the corrosion damage penetrated to a limited depth in the form of tiny pits connected in rows (also seen for Alloy-22). Corrosion damage appeared as a channel excavated around the outer perimeter of the crevice which eventually progressed to the middle of the creviced area.
